2018 HAZELTON WASTE MANAGEMENT FACILITY ANNUAL REPORT

June 2019

This annual monitoring report provides a synopsis of surface water and groundwater quality at the Hazelton Waste Management Facility, with a focus on water quality observed in 2018 relative to historical trends. Sampling that occurred in 2018 followed the amended Operational Certificate (OC) 17226. In 2018, two new Shallow Groundwater (SGW) wells, SGW-4 and SGW-5, were installed to monitor altered leachate flow patterns resulting from the Environmental Upgrades Project.

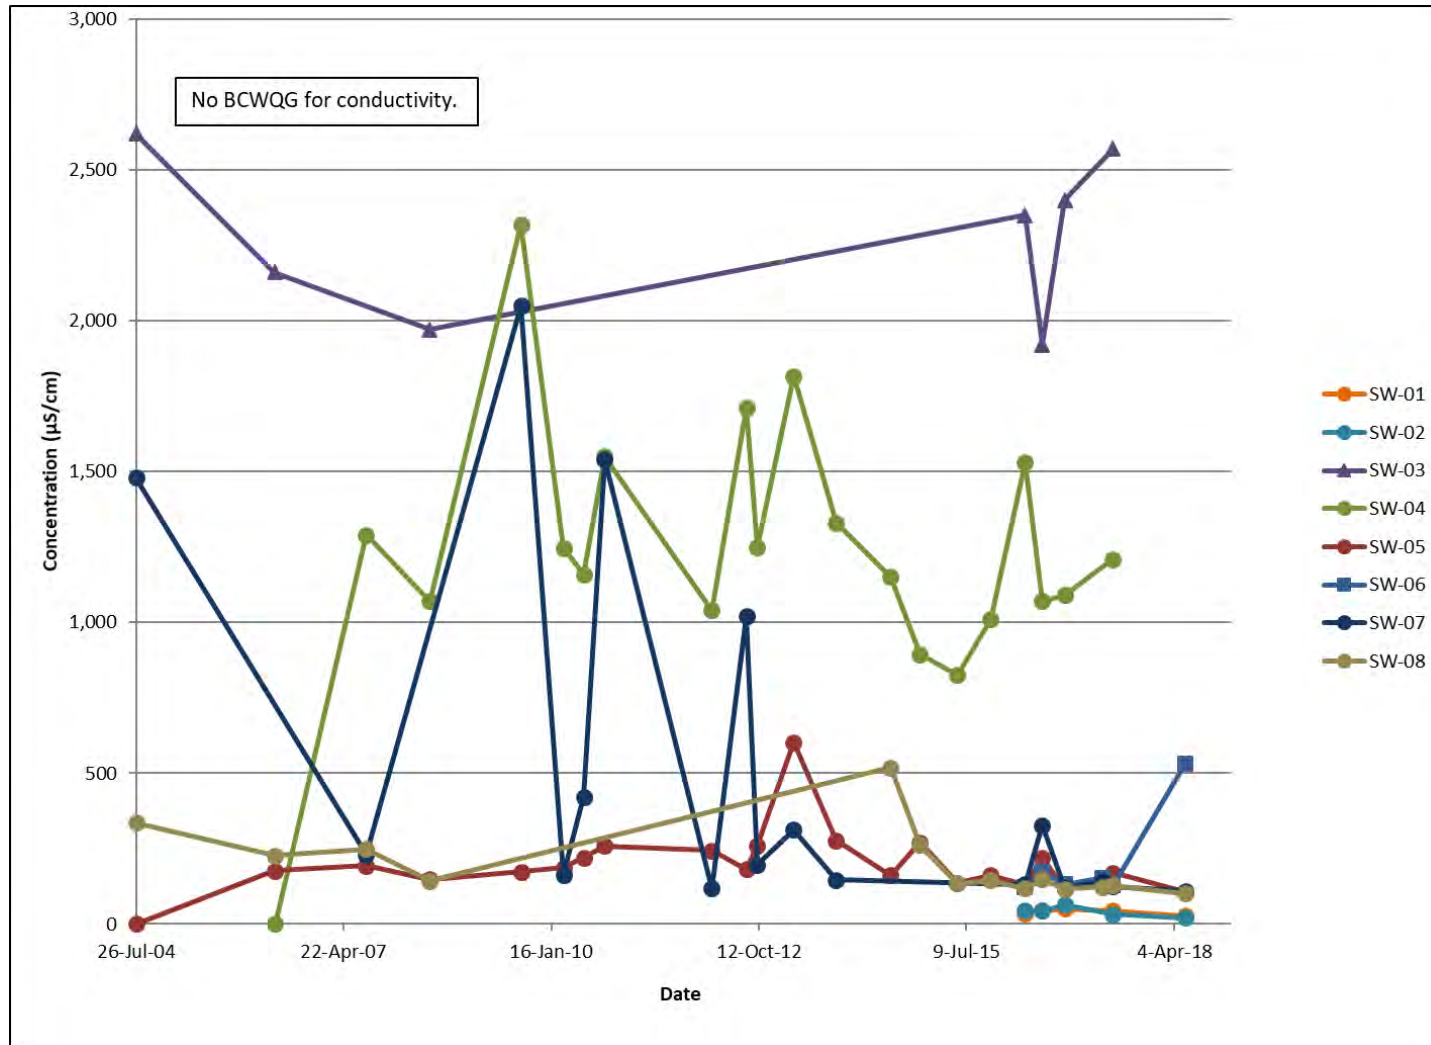
SCALE: N/A	DATE: 2019/02/22 <small>yyyy/mm/dd</small>	PROJECT NO: PRJ19009
DESIGNED	AM	DRAWING NO: Chart 1
DRAWN	AM	
CHECKED	DK

recorded as 28 $\mu\text{S}/\text{cm}$ at SW-01 and 21 $\mu\text{S}/\text{cm}$ at SW-02. These low conductivity values are representative of naturally occurring water with conductivity less than 200 $\mu\text{S}/\text{cm}$ that is impacted by metals naturally mobilized due to acidic conditions.

121 – 173 $\mu\text{S}/\text{cm}$. The elevated conductivity at this location could be due to runoff from the highway in the spring. However, if this was the case then one would expect SW-08 to have elevated conductivity as well and the conductivity recorded at SW-08 was 102 $\mu\text{S}/\text{cm}$. Therefore, the cause of the elevated conductivity at this location is unknown at this time. This sampling location should be monitored to confirm that conductivity returns to normal levels in future years.

TITLE:
Surface Water Conductivity

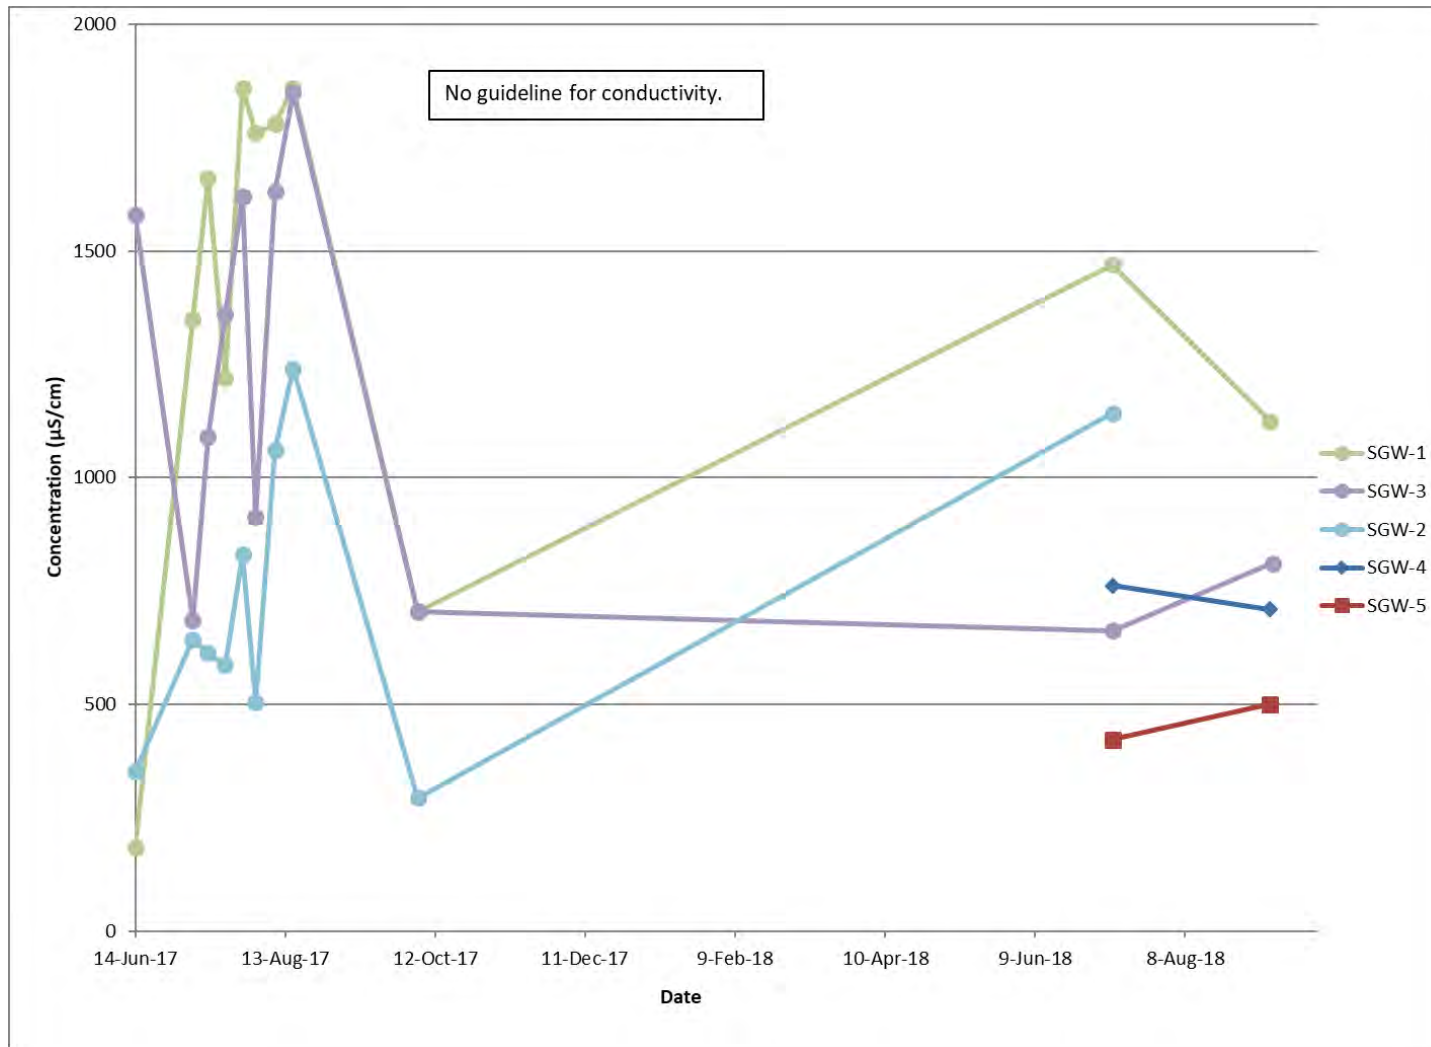
SCALE: N/A	DATE: 2019/02/22 <small>yyyy/mm/dd</small>	PROJECT NO: PRJ19009
DESIGNED	AM	DRAWING NO: Chart 6
DRAWN	AM	
CHECKED	DK

Shallow groundwater quality results are tabulated in Table 2 (Appendix B). Charts 6 to 11 show the overall shallow groundwater quality trends. This year, all SGW wells were sampled for dissolved metals. Last year, it should be noted that all the SGW wells were sampled for total metals rather than dissolved metals and as such, any sediments stirred up during well purging would have affected the results. Therefore, charts for shallow groundwater metals only show results for the 2018 year (dissolved metals).

TITLE:
Shallow Groundwater Conductivity

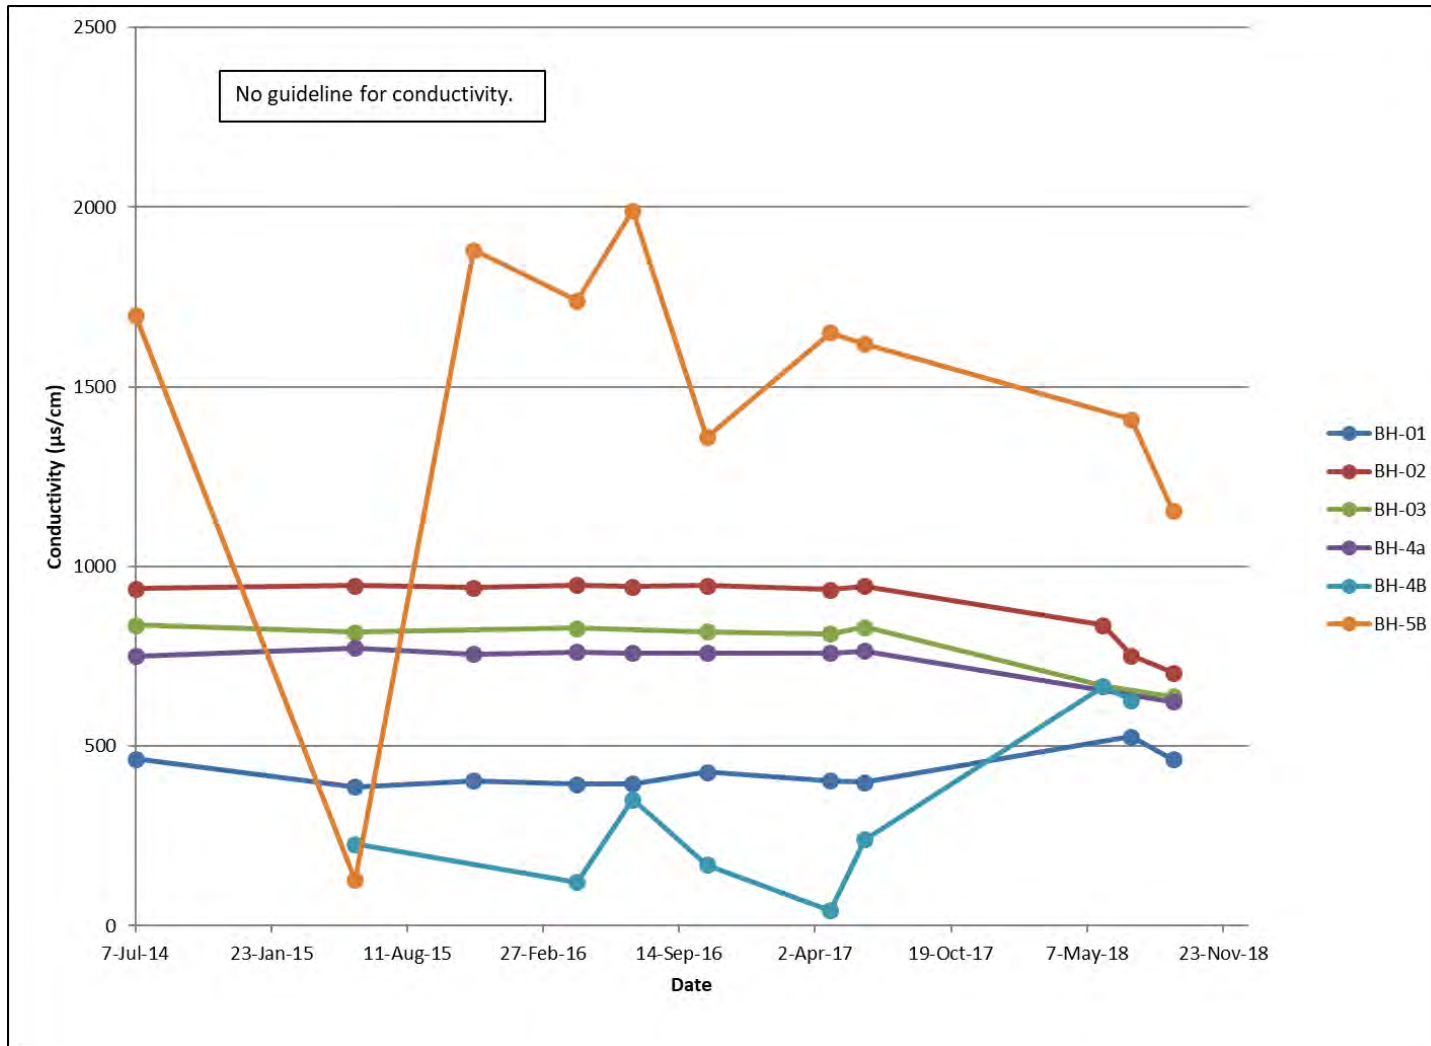
SCALE: N/A	DATE: 2019/02/22 <small>yyyy/mm/dd</small>	PROJECT NO: PRJ19009
DESIGNED	AM	DRAWING NO: Chart 12
DRAWN	AM	
CHECKED	DK

There were no exceedances of the guidelines at BH-03 in 2018. Furthermore, conductivity has decreased at this location compared to 2017. However, conductivity is still elevated and ranged from 638 to 667 mg/L. Conductivity is similarly high in background wells. Furthermore, leachate indicators were not appreciably elevated above background conditions. Notably, chloride levels were basically equal to those of background concentrations

Monitoring location BH-5B is the only well that is downgradient of the landfill. Its results showed potential evidence of leachate impact. It had elevated conductivity values that were higher than background and elevated chloride concentrations that were much higher than background conditions and similar to those found at the leachate seep. However, several of the exceedances are similar to background conditions. Also, it is difficult to determine the portion of contamination resulting from nearby highway operations. For these reasons, it is difficult to determine whether or not the landfill is impacting groundwater at the downstream BH-5B monitoring location.

TITLE:
Groundwater Conductivity
